Report No: 04-009 FE ASTM

Testing : Polycarbonate Hurricane Shutter Panels

Transparent Protection Systems, Inc.

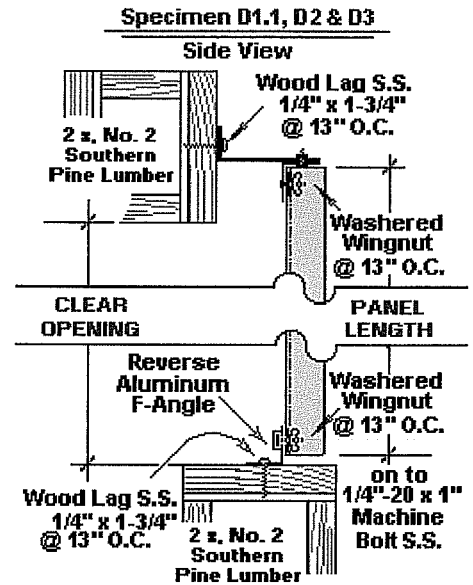
Wind Load Data : Specimen D1.1

Shear Failure at ~20-1/4" H2O, at head, 2nd & 3rd panel overlap torn from fastener.

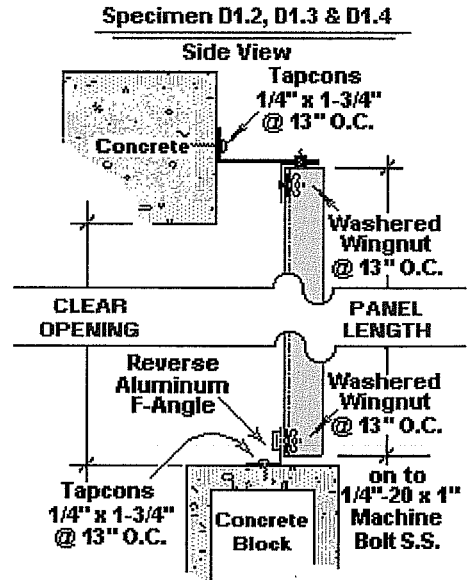
Wind Load Data : Specimen D1.2

Shear Failure at ~19-1/2" H2O, at sill, 1st & 2nd panel overlap torn from fastener.

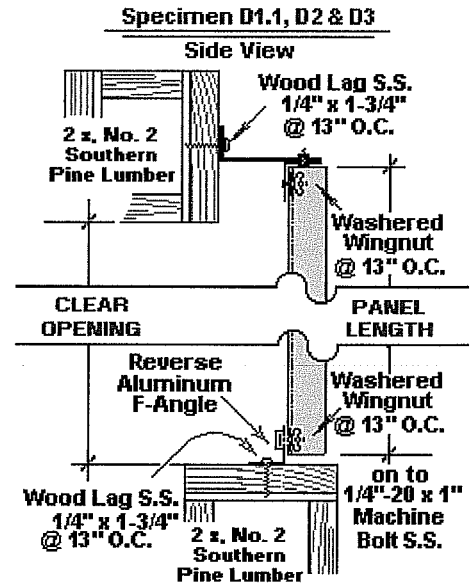
Wind Load Data : Specimen D2

Shear Failure at ~11-1/2" H2O, at sill, 2nd panel of three torn from fasteners.

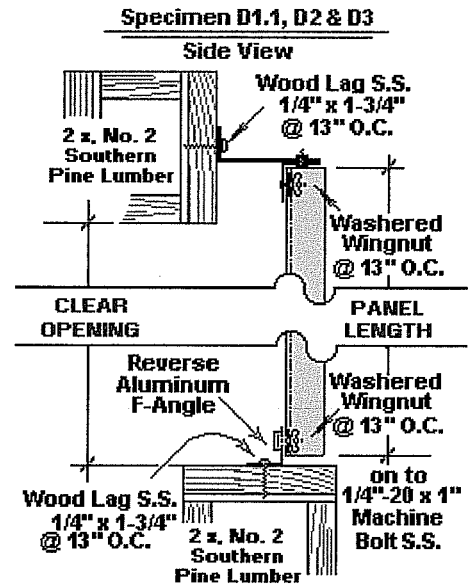
Wind Load Data : Specimen D3

Shear Failure at ~27-1/2" H2O, at sill, 1st & 2nd panel overlap, torn from fastener.
